**CANADIAN FORCES  
FLIGHT SAFETY INVESTIGATION (FSI)**

**FINAL REPORT**

**FILE NUMBER:** 1010-139314  
**DATE OF REPORT:** 16 April 2003  
**AIRCRAFT TYPE:** CH139 JET RANGER  
**DATE/TIME:** 280417Z Jun 2002  
**LOCATION:** Southport, MB  
**CATEGORY:** "B" CATEGORY ACCIDENT

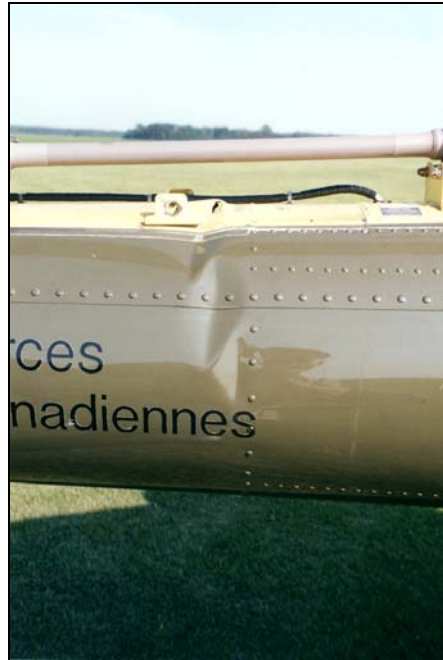
The skid gear was slightly splayed. The tail boom flexed in both directions of the vertical plane causing buckling (Photo 1 and 2). The spike box on the underside of the transmission was sheared and both pitch horns were gouged from contact with the aft transmission housing. The aircraft was sent to third line contractor to repair the tail boom. Damage was assessed as 'B' CAT.

**Photo 1: Tail boom – starboard side buckling  
Poutre de queue – gauchissement côté droit**

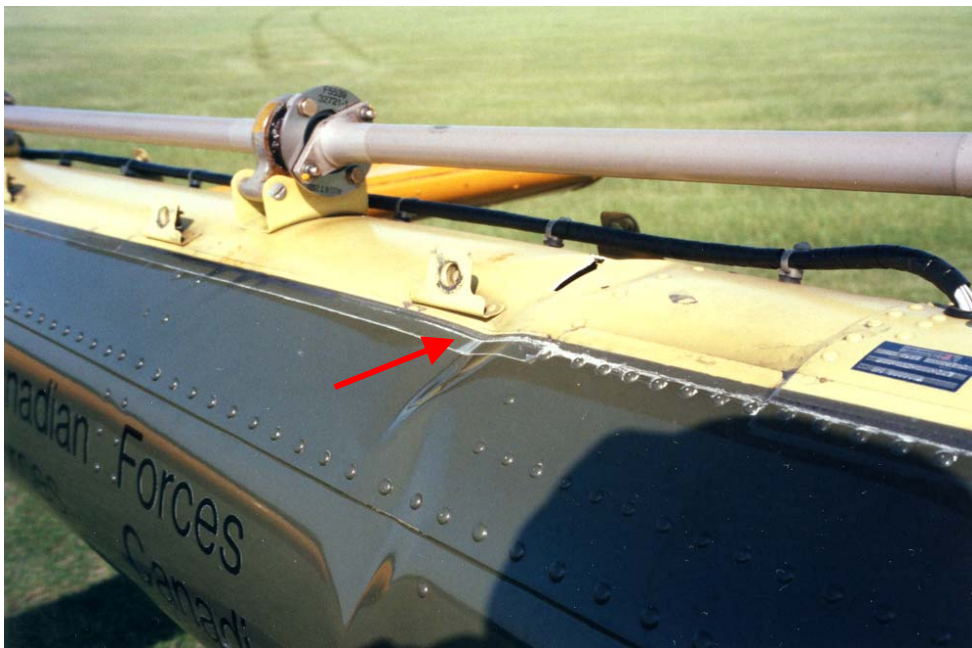
**Photo 2: Tail boom – looking aft  
Poutre de queue – vue vers l'arrière**
